TUOLUMNE UTILITIES DISTRICT

Phoenix Lake Preservation and Restoration Plan - 30% Plan Submittal

Phoenix Lake Preservation and Restoration Plan – Chapter 4 - Water Quality
Monitoring & Improvement Plan

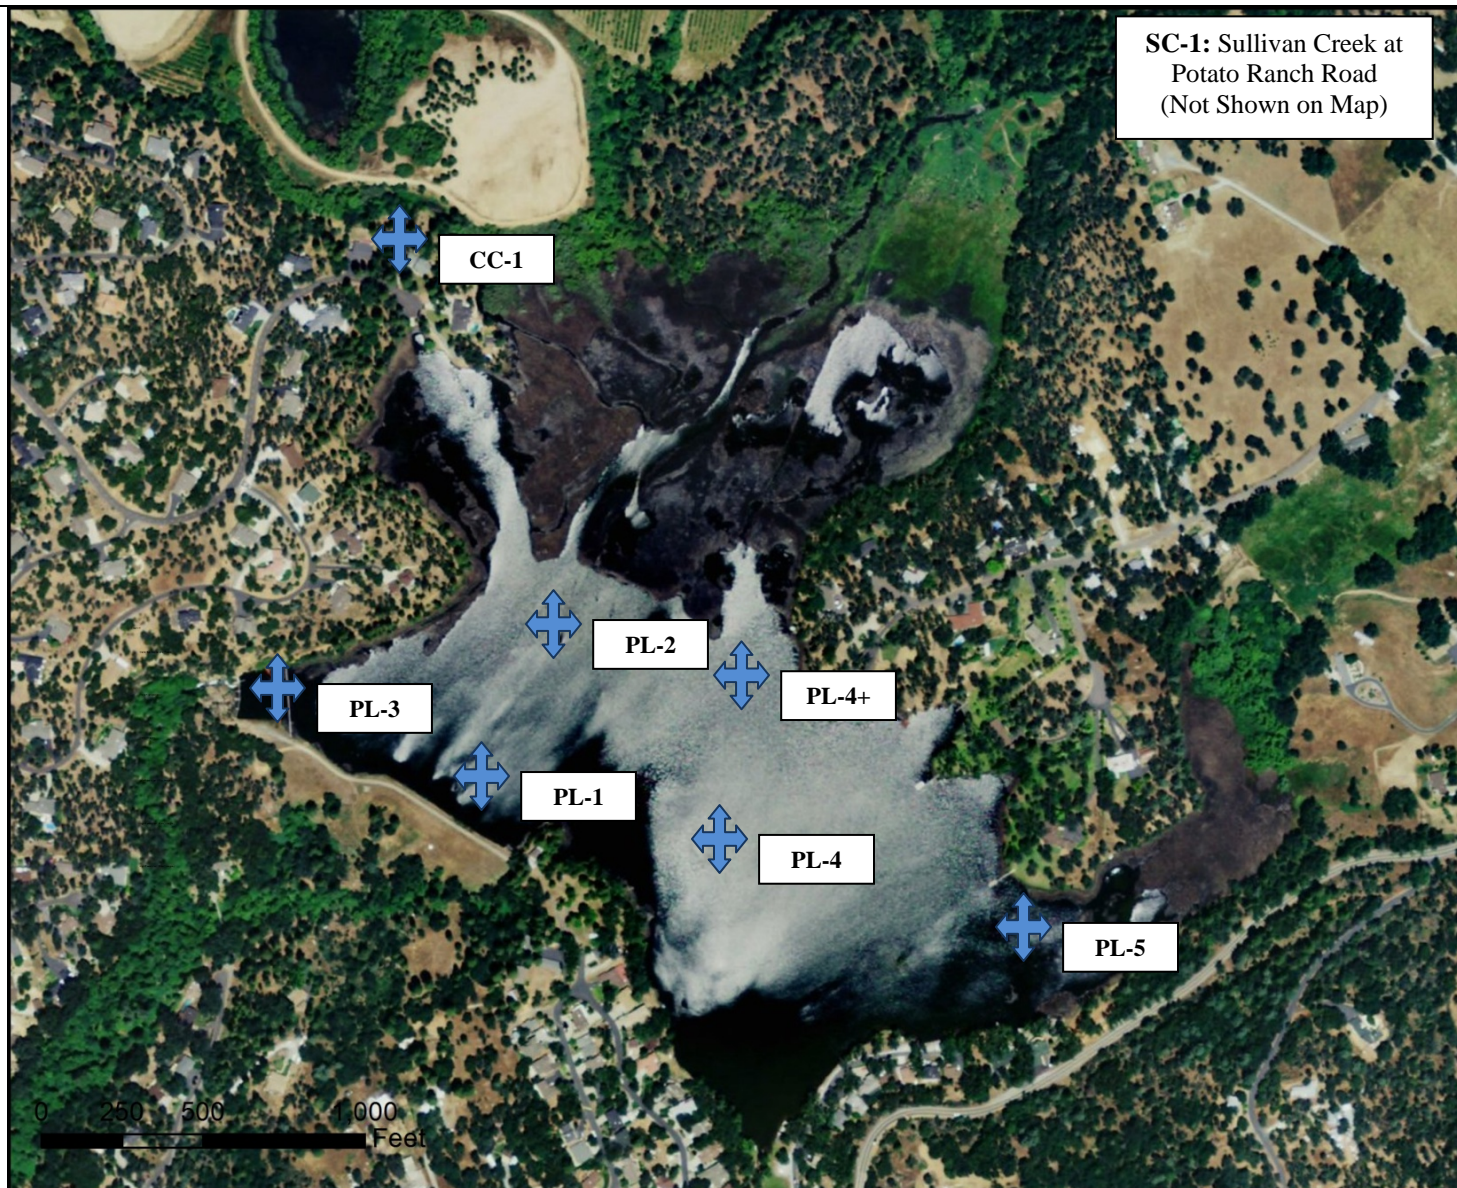
Figure 4-1

Phoenix Lake Preservation & Restoration Plan
Water Quality Sampling Sites

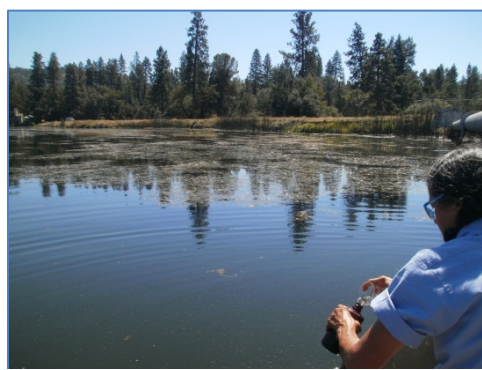
Photo 4-1: Water sample collection in Phoenix Lake (September 20, 2011)

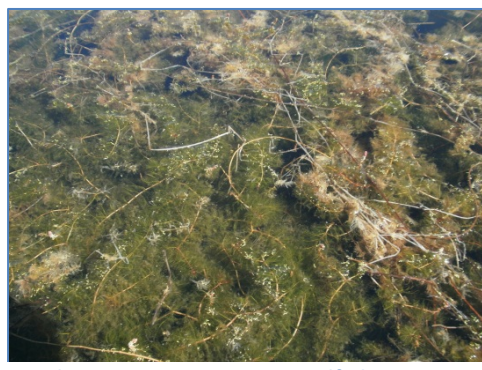
Photo 4-2: Eurasian watermilfoil mats in Phoenix Lake

Land use and natural environmental discharges to a shallow, warm-water lake heavily influence water quality, particularly related to inputs of sediment, nutrients, and bacteria. Nutrient discharges encourage growth of aquatic vegetation such as the invasive, non-native Eurasian watermilfoil (*Myriophyllum spicatum*, Photo 4-2).

Aquatic vegetation stores energy and nutrients in its roots during the winter and grows rapidly in the spring, forming thick dense mats in the lake. The lifecycle of aquatic vegetation influences water quality in a lake. As light availability and temperatures rise throughout the day, the photosynthetic activity in plants increases and oxygen is released to the upper water column. At the highest peak of temperatures in the day, oxygen levels near the lake surface become supersaturated (beyond 100% saturated). In this condition, aquatic vertebrates like fish avoid the area. As the season gets cooler and aquatic vegetation dies off, dead vegetative matter sinks to the lake bottom. The decomposition process at the lake bottom uses available oxygen in the water
